BOARD OF HISTORIC PRESERVATION
WEDNESDAY JUNE 12, 2024
4:00 PM City Center, Cooper Conference Room, 110
Sioux Falls, SD

CITY OF SIOUX FALLS - BOARD OF HISTORIC PRESERVATION SUBMITTAL

BATHHOUSE / WARMING HOUSE

Project Review	June 12, 2024
Property Address	1005, 1023, 1027 S. Dakota Ave. and 414 W. 19 th St.
Property Owner	Justin & Chrissy Johnson Sioux Falls, SD
Applicant	Paul Reynolds, RCM Construction Management
Historic District	Sherman Historic District
Properties	Historic information of individual properties is included in the following report.
Project Representative	Paul Reynolds, RCM Construction Management
Applicant Project Description.	The project will require demolishing four historic structures on Dakota Avenue and 19 th Street. Due to the Current dilapidated state of the structures and excessive cost to attempt and restore these structures, it has been determined that the only way for the upcoming project to succeed is for the structures will be required to be razed. We have investigated the option to relocate the existing structures, but due to the dilapidated state, we are not able to safely and properly relocate them. It is our goal to remove the four homes and reb

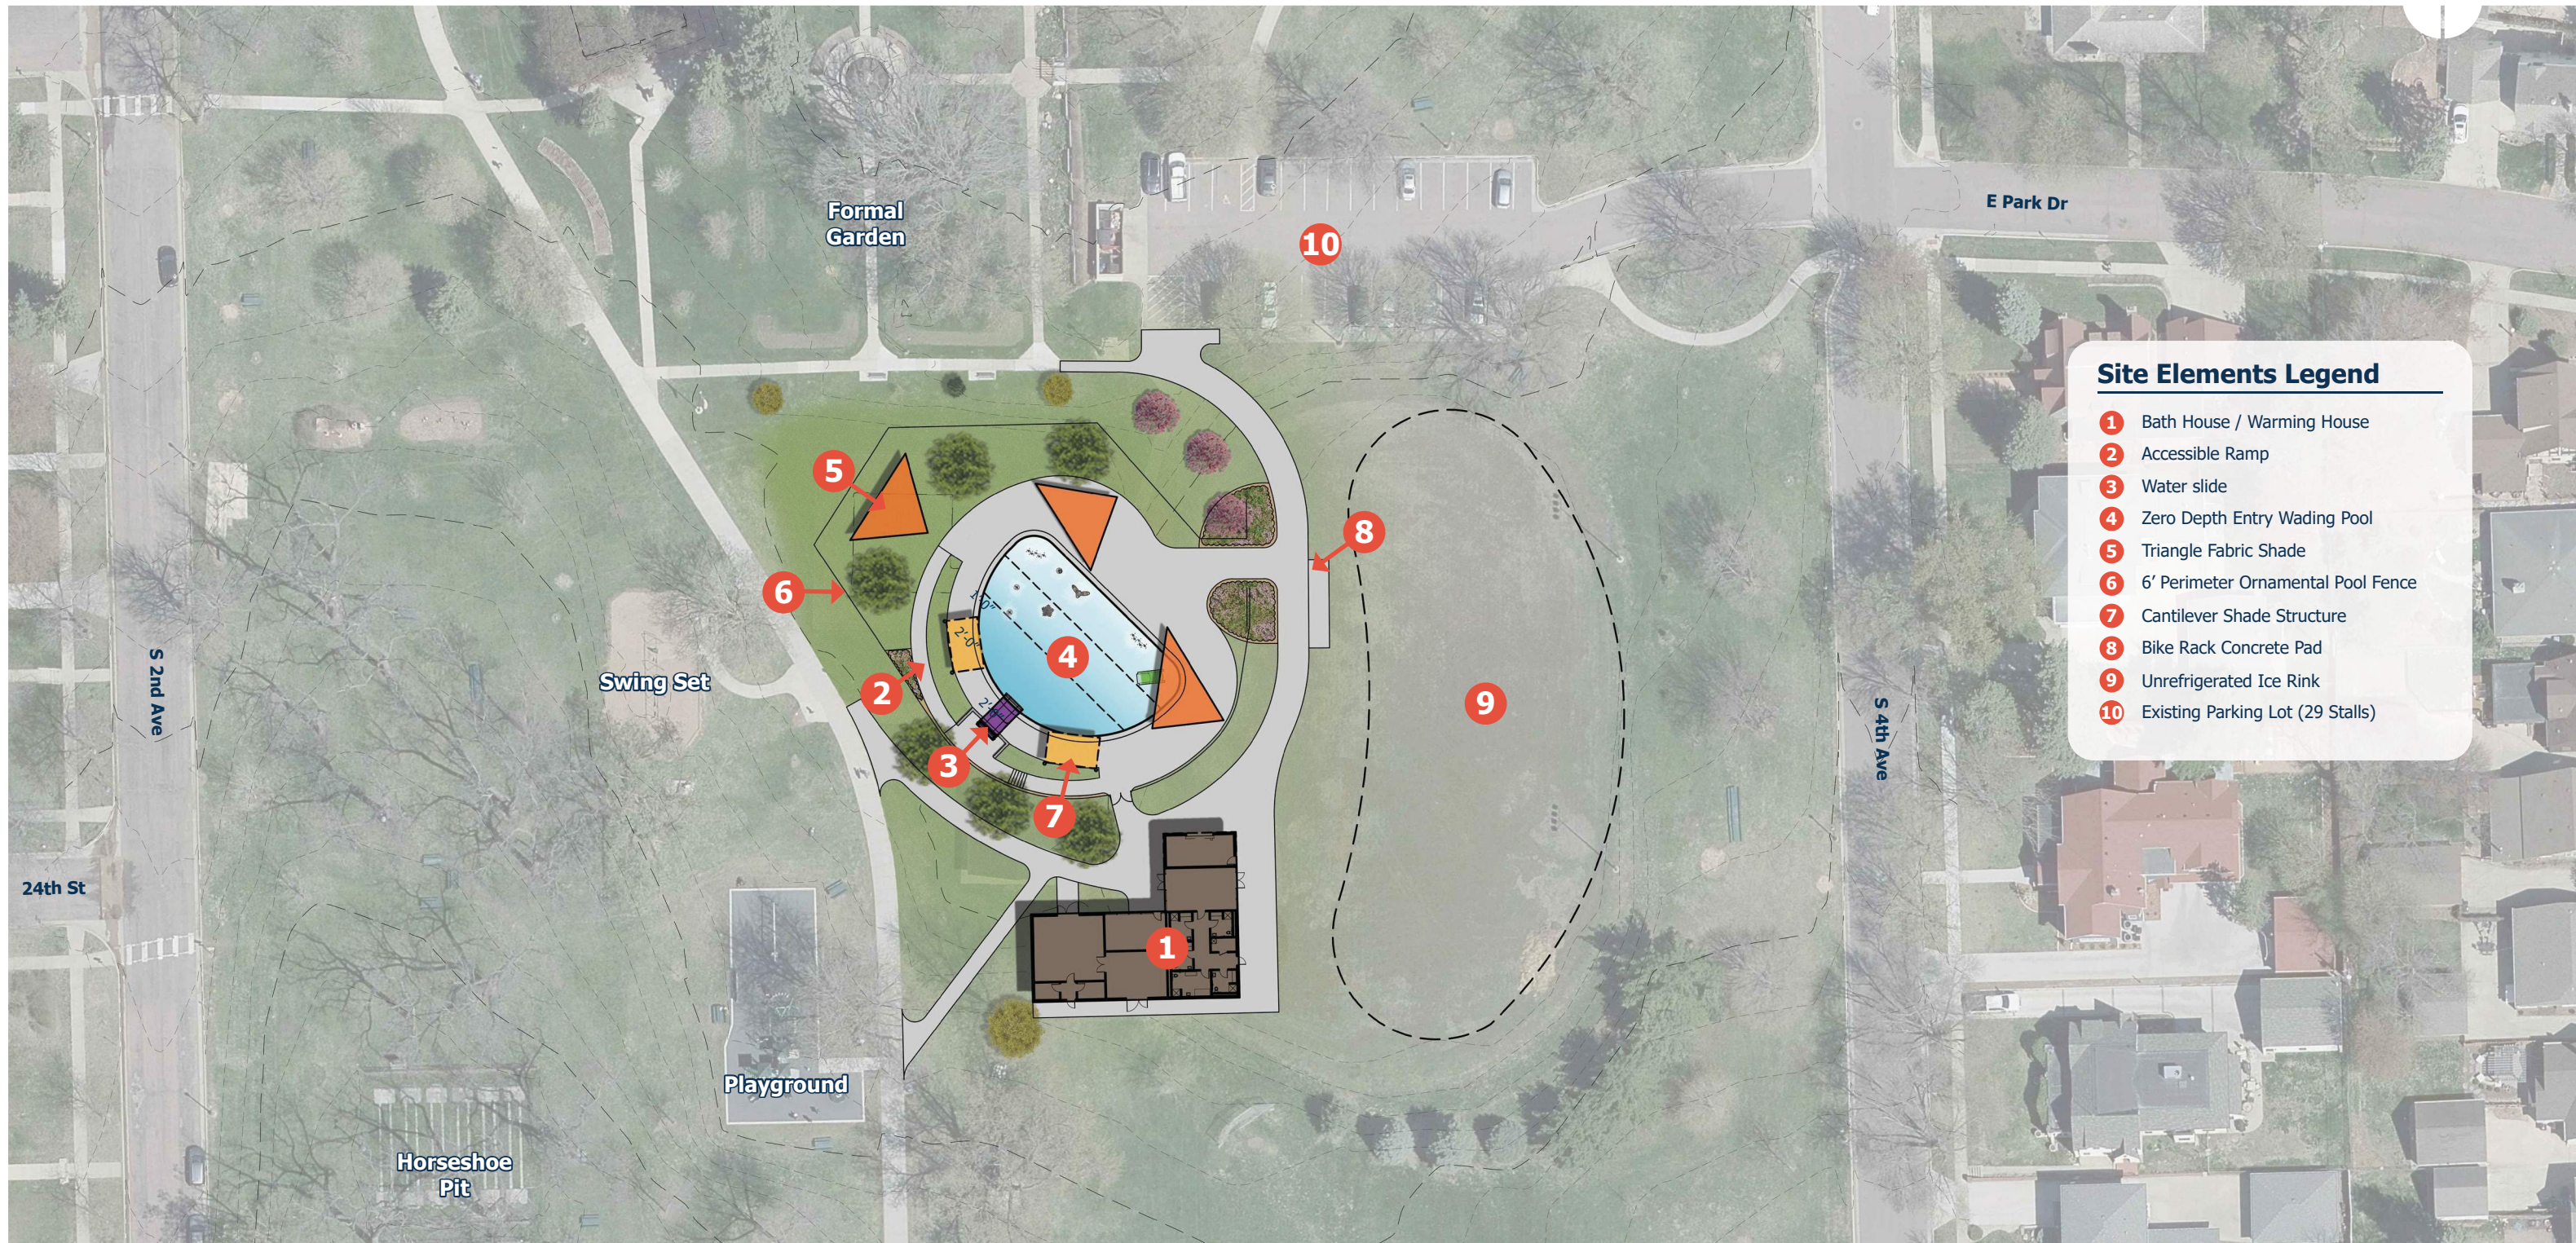
SITE PLAN

- 1 Bath House / Warming House
- 2 Accessible Ramp
- 3 Water slide
- 4 Zero Depth Entry Wading Pool
- 5 Triangle Fabric Shade
- 6 6' Perimeter Ornamental Pool Fence
- 7 Cantilever Shade Structure
- 8 Bike Rack Concrete Pad
- 9 Unrefrigerated Ice Rink
- 10 Existing Parking Lot (29 Stalls)

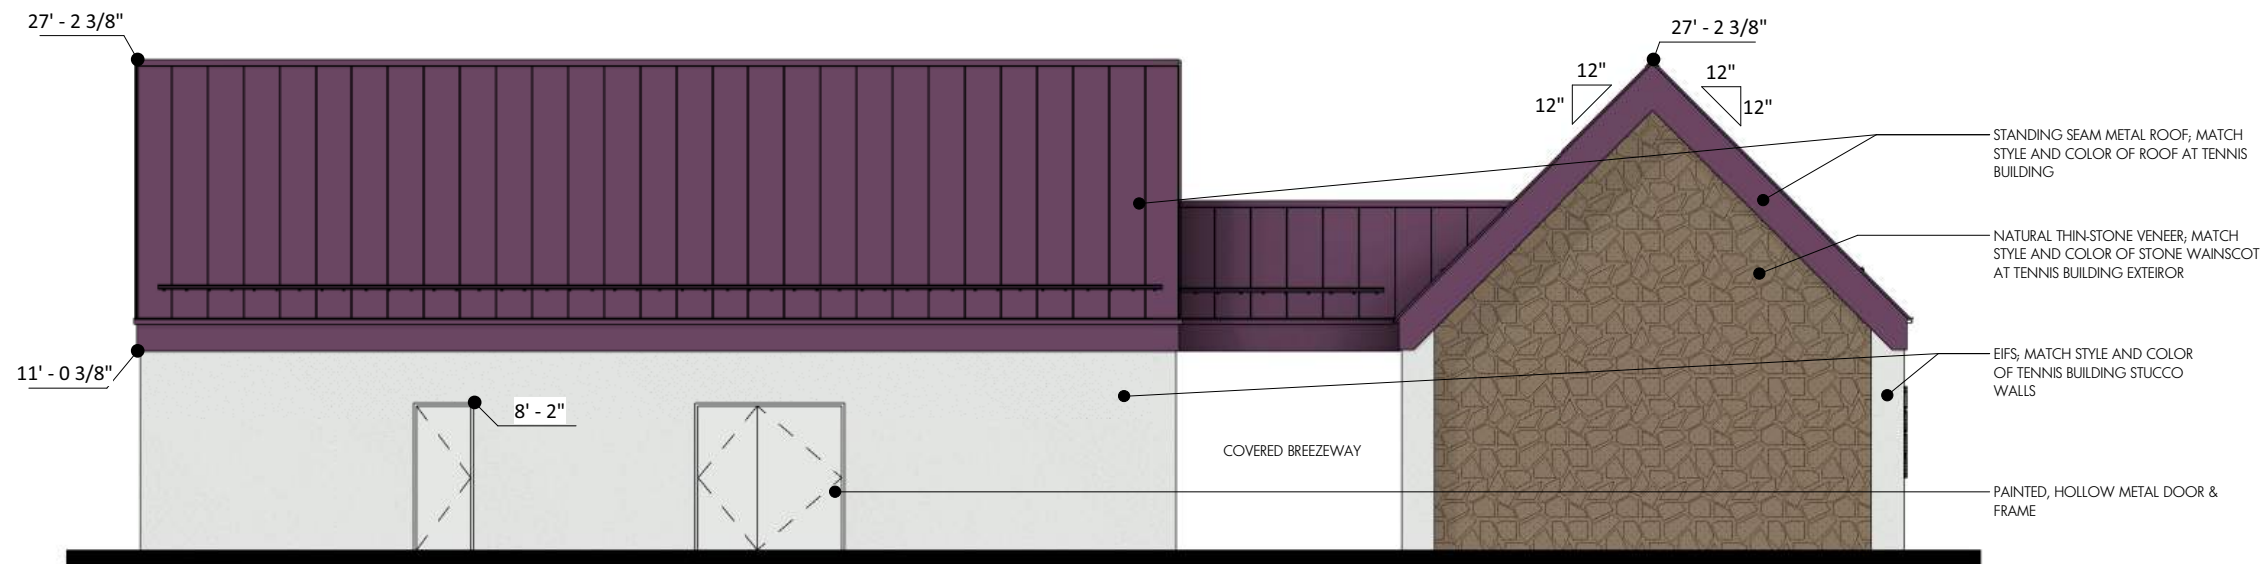
SOUTH ELEVATION

SCALE: 1/8" = 1'-0"

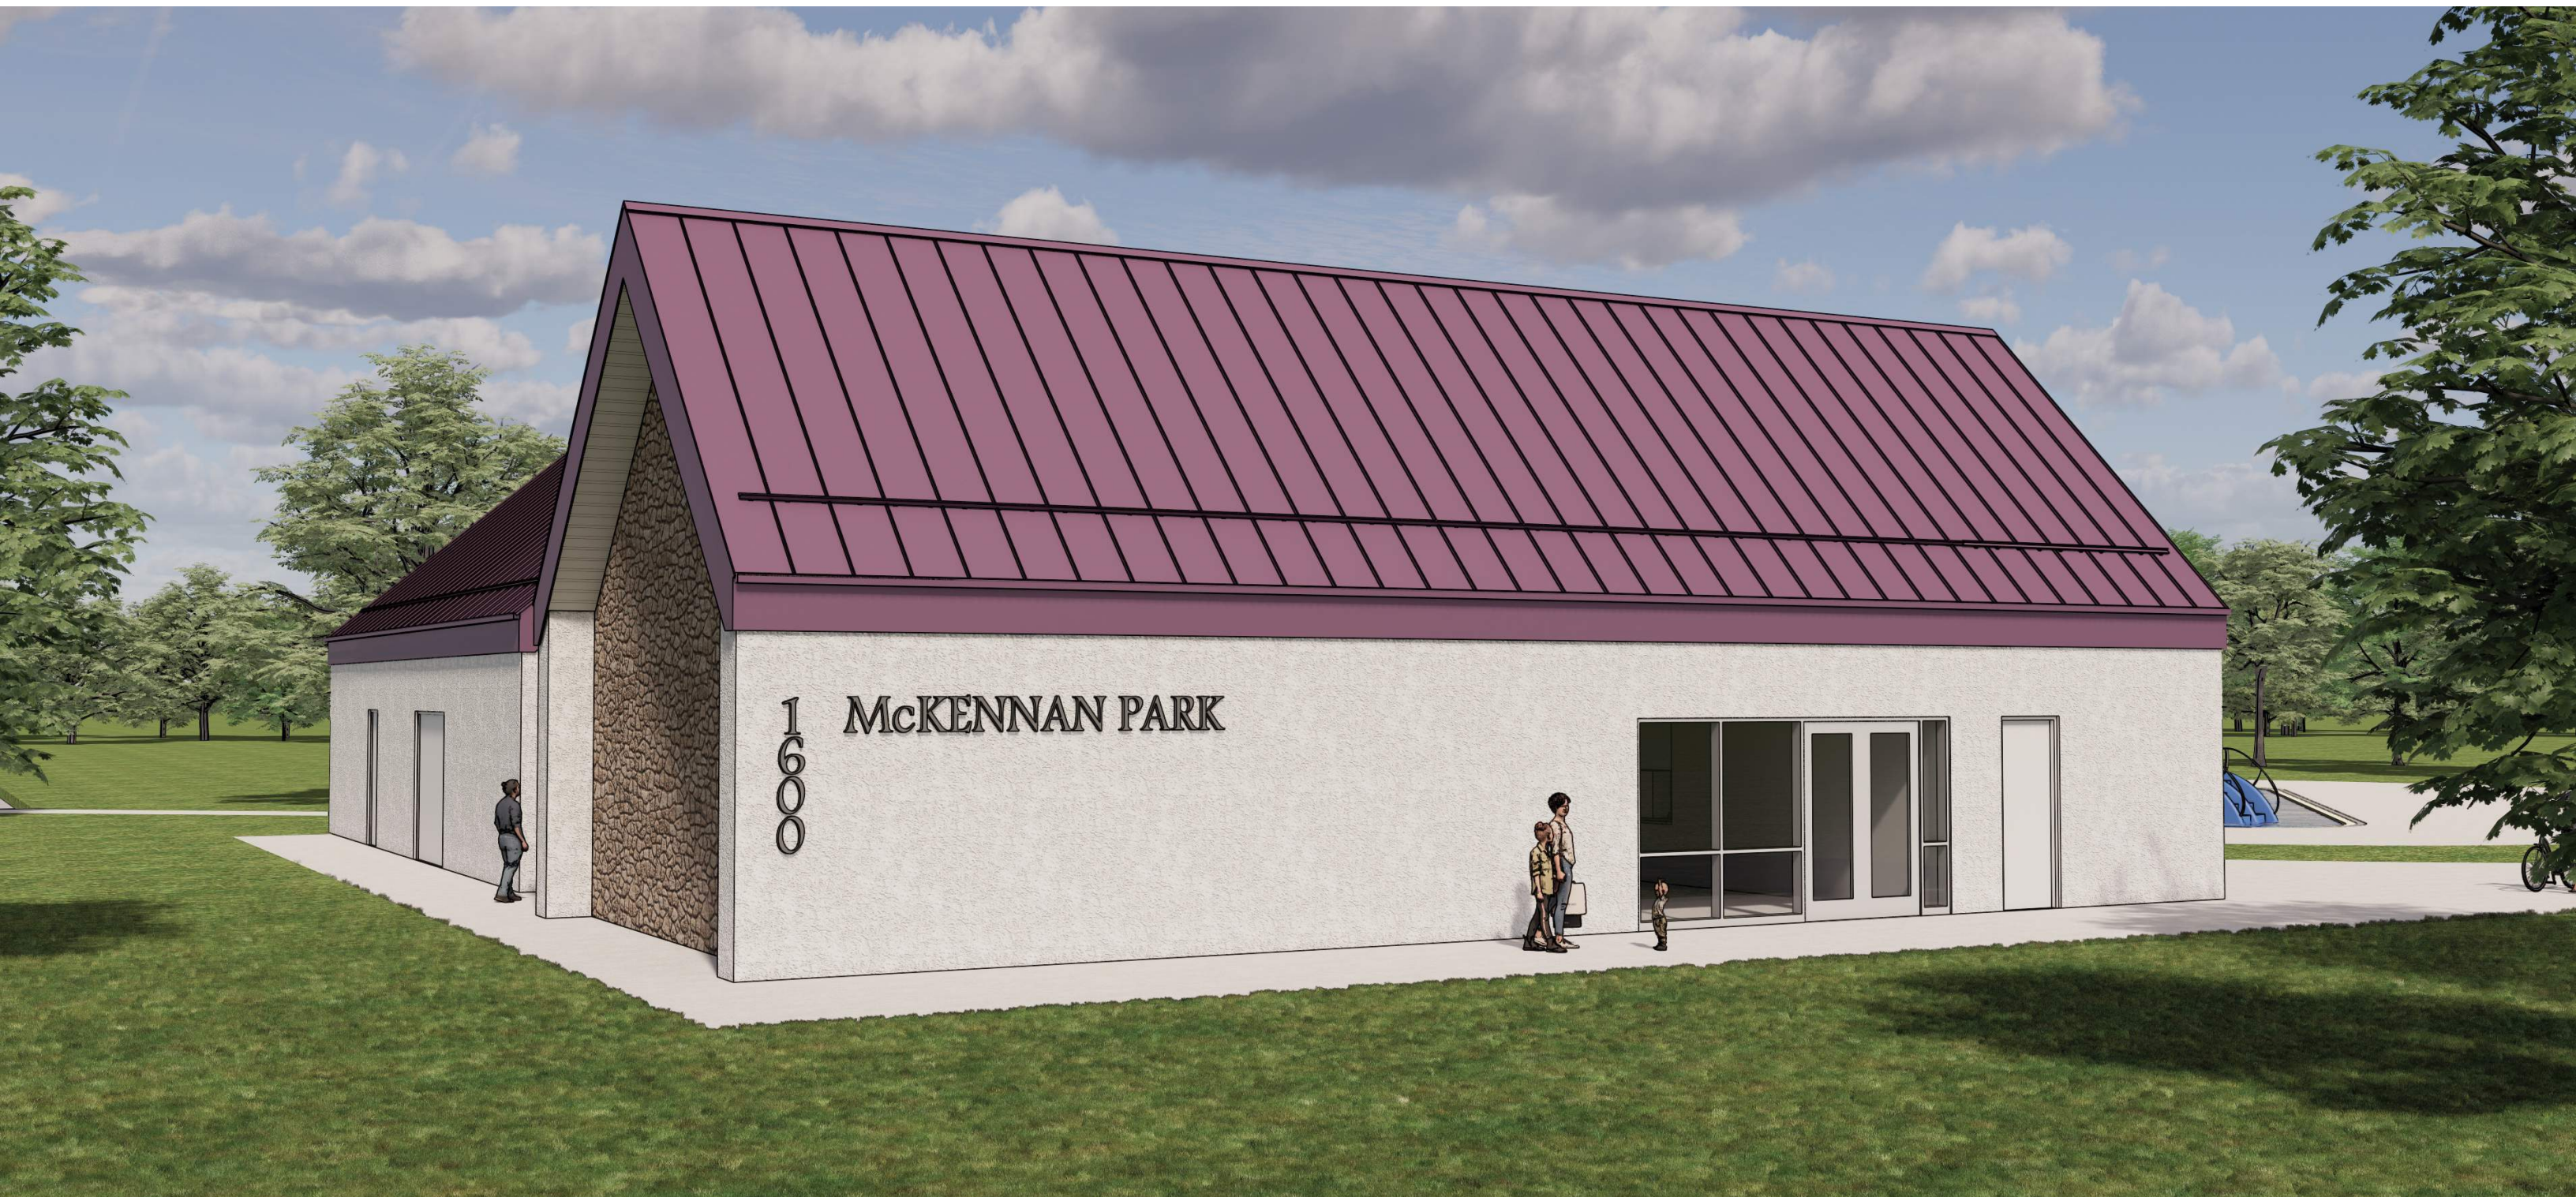
CONCEPTUAL RENDERING

The second influence is taken from the existing buildings and features within the park itself. The tennis building, picnic pavilion, bandshell, and park signage have distinct and mostly shared materials - white stucco, stone wainscoting, red roofs either in the form of standing seam metal roof, or terracotta tile. The new bathhouse/warming house design utilizes similar materials.

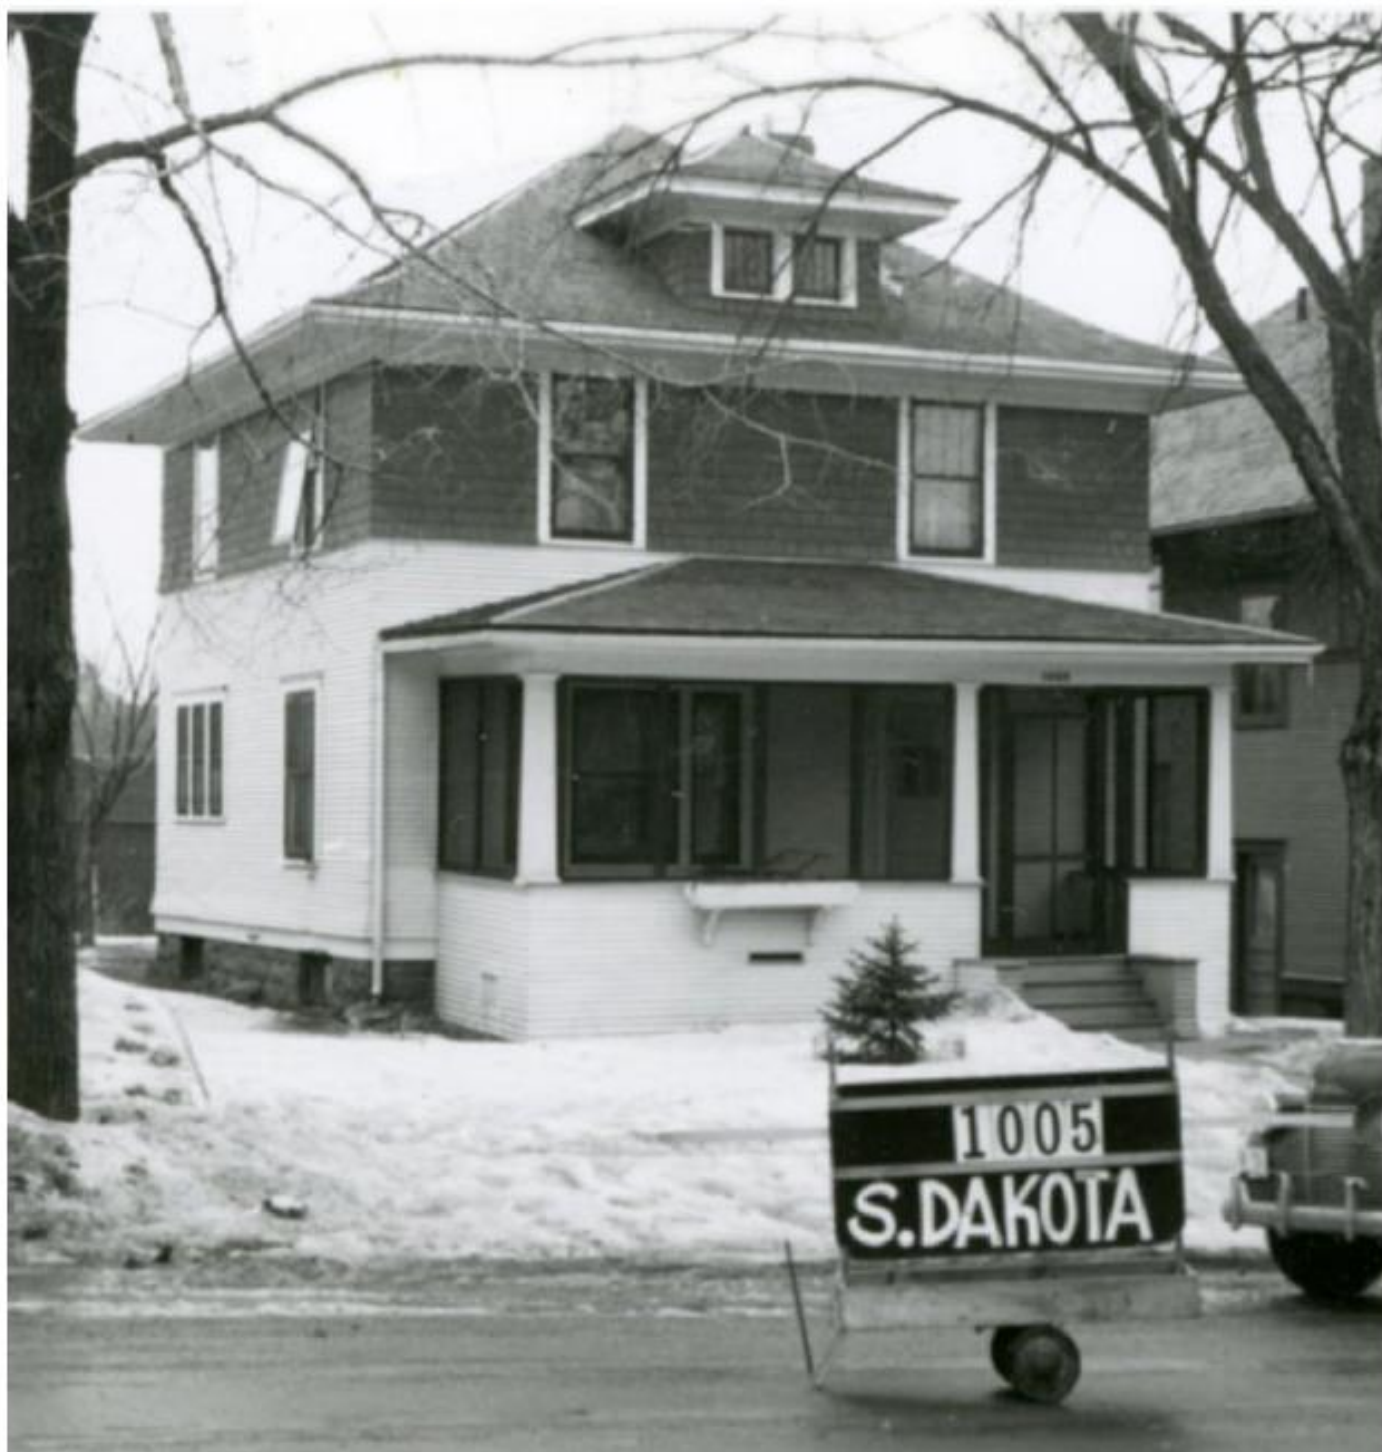
1005 S. Dakota Avenue – Historic Photo

Constructed in 1915, this two-story Prairie style residence has a hipped, asphalt roof and a half-hipped asphalt roof on the one-story front porch. The house has had vinyl siding added. The screened-in front porch has low, solid walls which support battered wood columns that extend to the porch roof. The entrance is asymmetrical, with the door on the northern side of the façade. The southern half of the façade contains a large one-over-one double-hung sash windows. The second story contains original four-over-one wood double-hung sash windows.

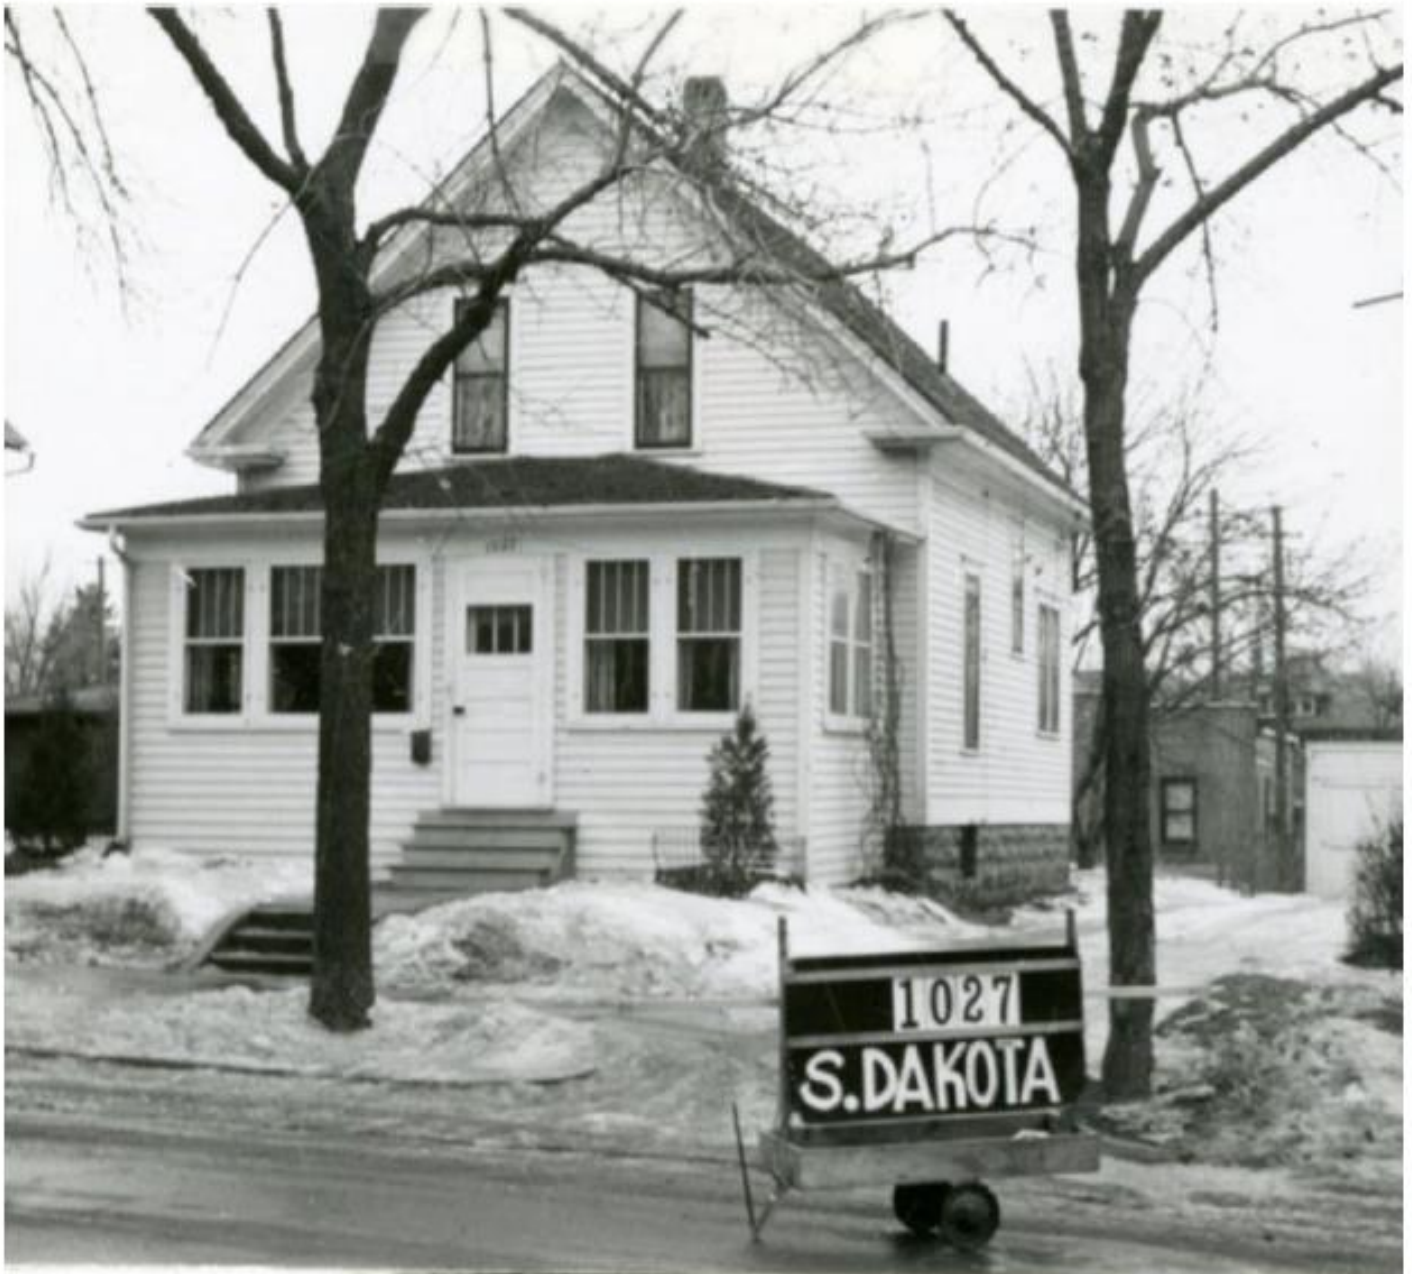
1027 S. Dakota Avenue – Historic Photo

Constructed in 1905, this one-story national Folk house has a steeply pitched front gabled asphalt roof with eave returns, and the original narrow clapboard siding. The full-width front porch has a half hipped asphalt roof and contains the slightly off-centered entrance flanked by ribbons of windows. Centered above the front porch in the gable are two narrow, one-over-one double-hung sash windows. A non-contributing one-story, single stall garage with a front gabled roof and wide wood siding is located in the rear. The garage has been altered.

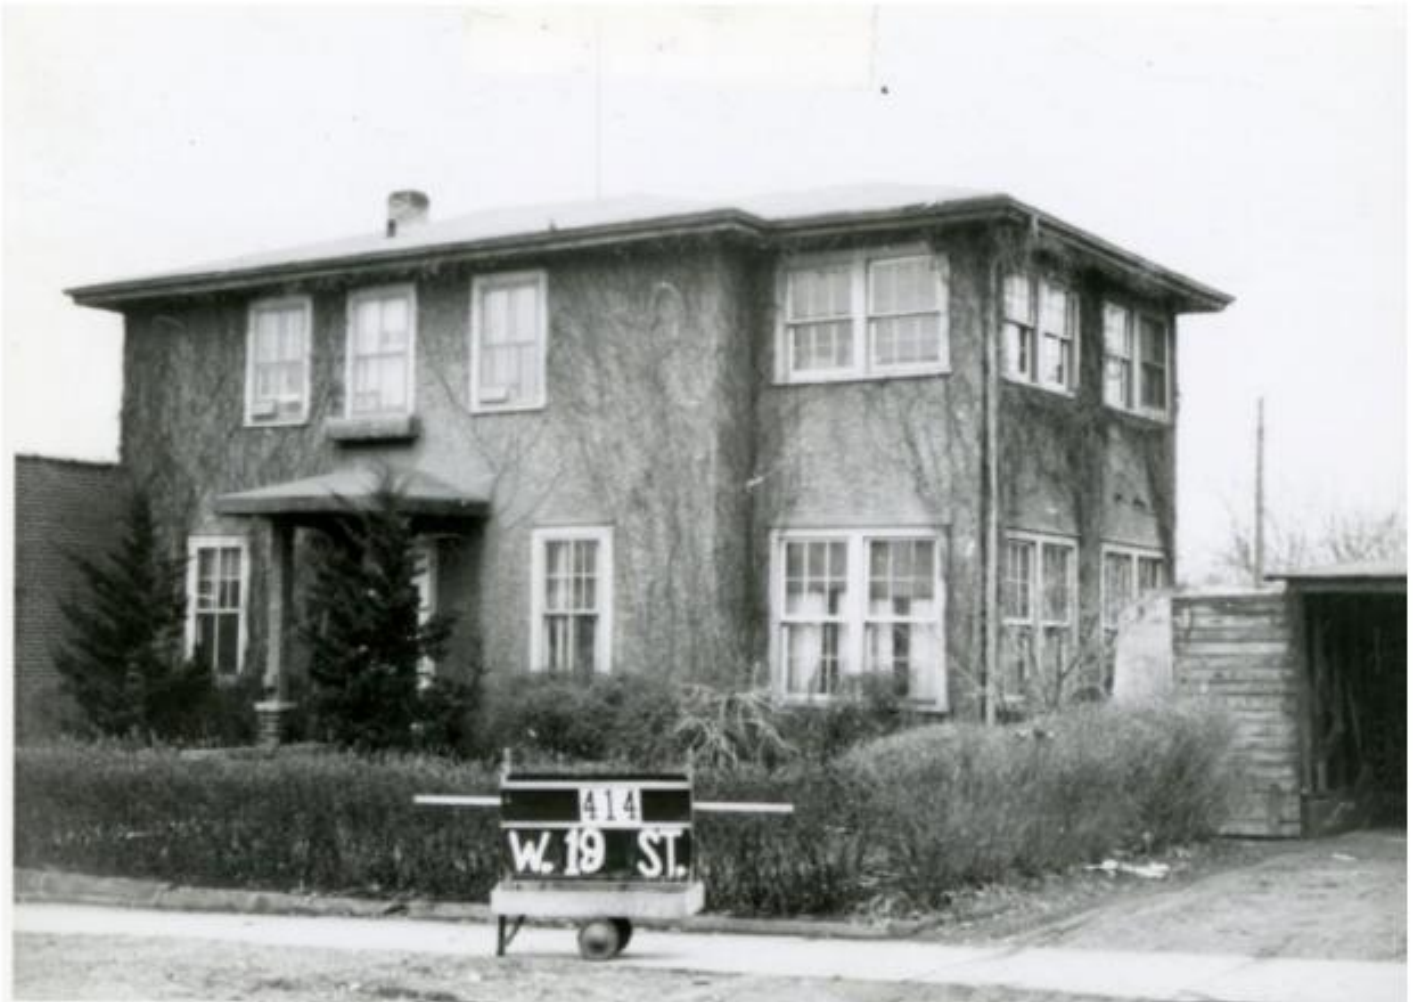
414 W. 19th Street – Historic Photo

Constructed in 1926, this two-story Prairie residence has a hipped asphalt roof with wide overhanging boxed eaves and stucco-clad walls. Recessed back several feet from the façade, the eastern portion of the structure contains a series of six-over-six double hung sash windows. Located in the western portion of the façade, the entrance is covered by a hipped roof portico that is supported by square stucco columns which rest on low brick piers. A contributing one-story, single stall garage with a front gable roof is located to the east of the residence. The garage has clapboard siding on the south facing façade and stucco that matches the residence on the sides and rear.

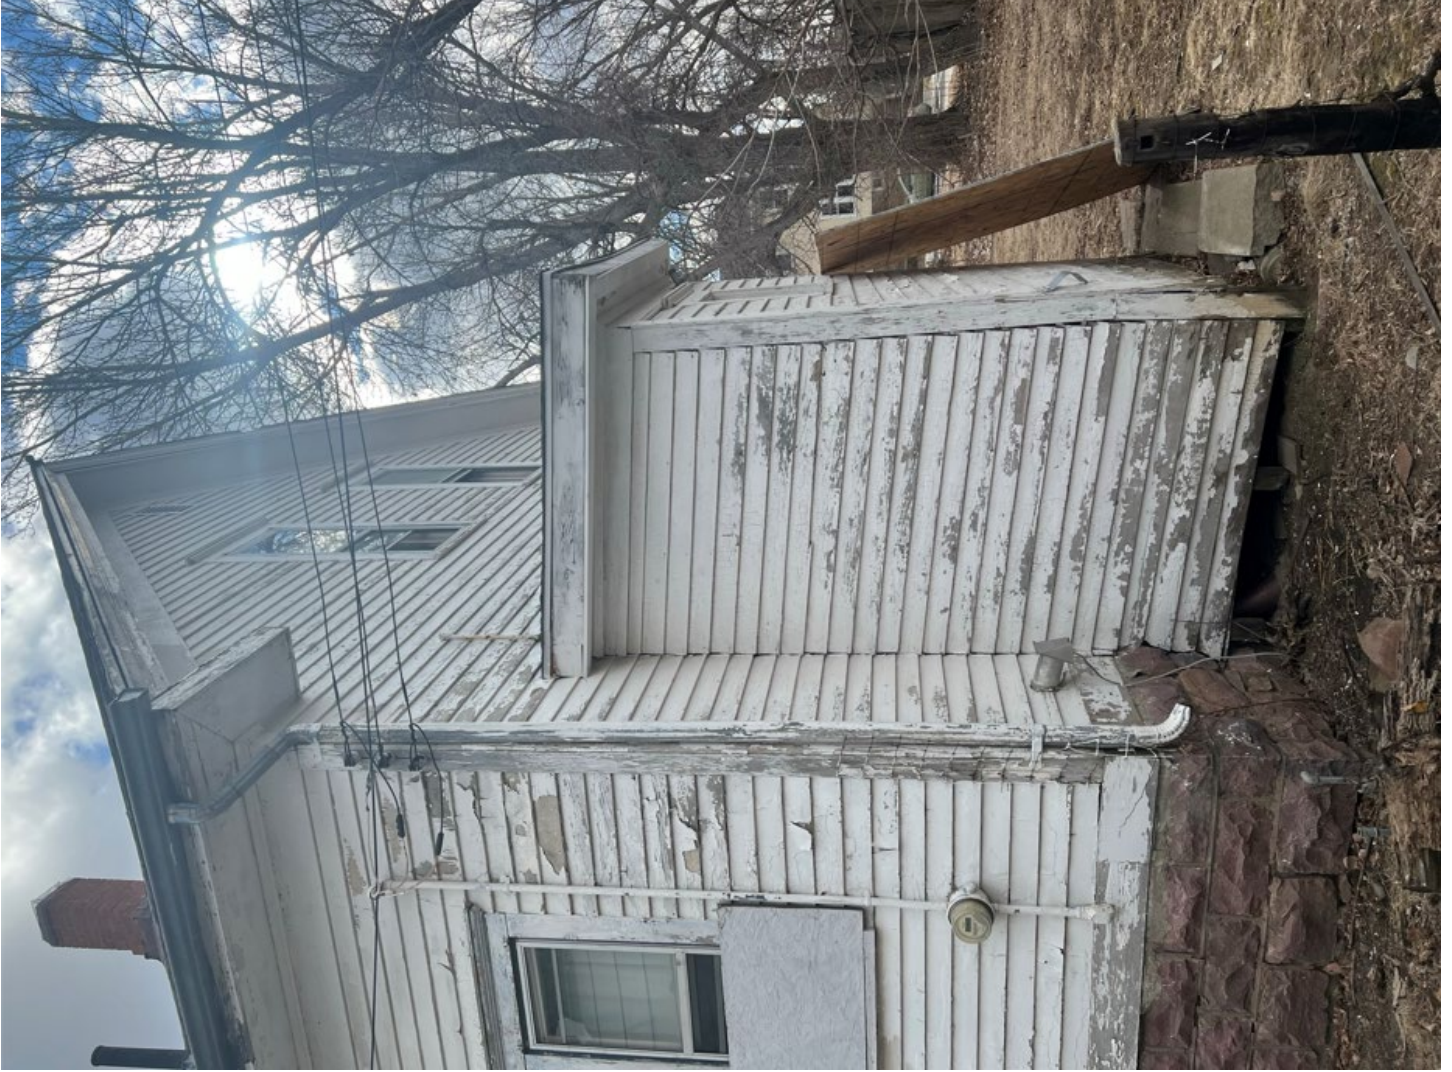
1027 S. Dakota Avenue

Settlement was observed in
west exterior structure

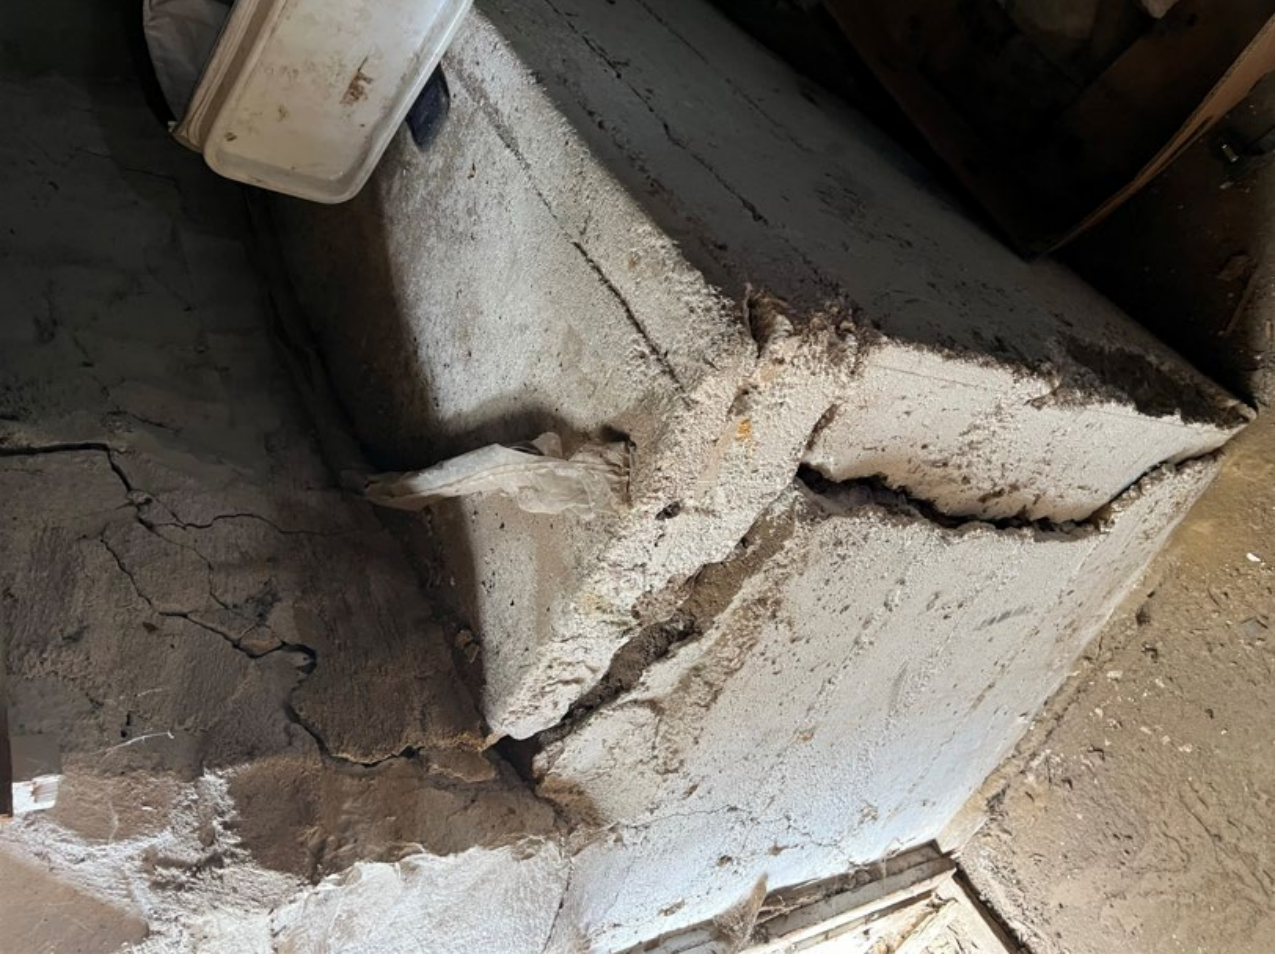
414 West 19th Street
Chimney structure observed to have
partially collapsed within roof structure

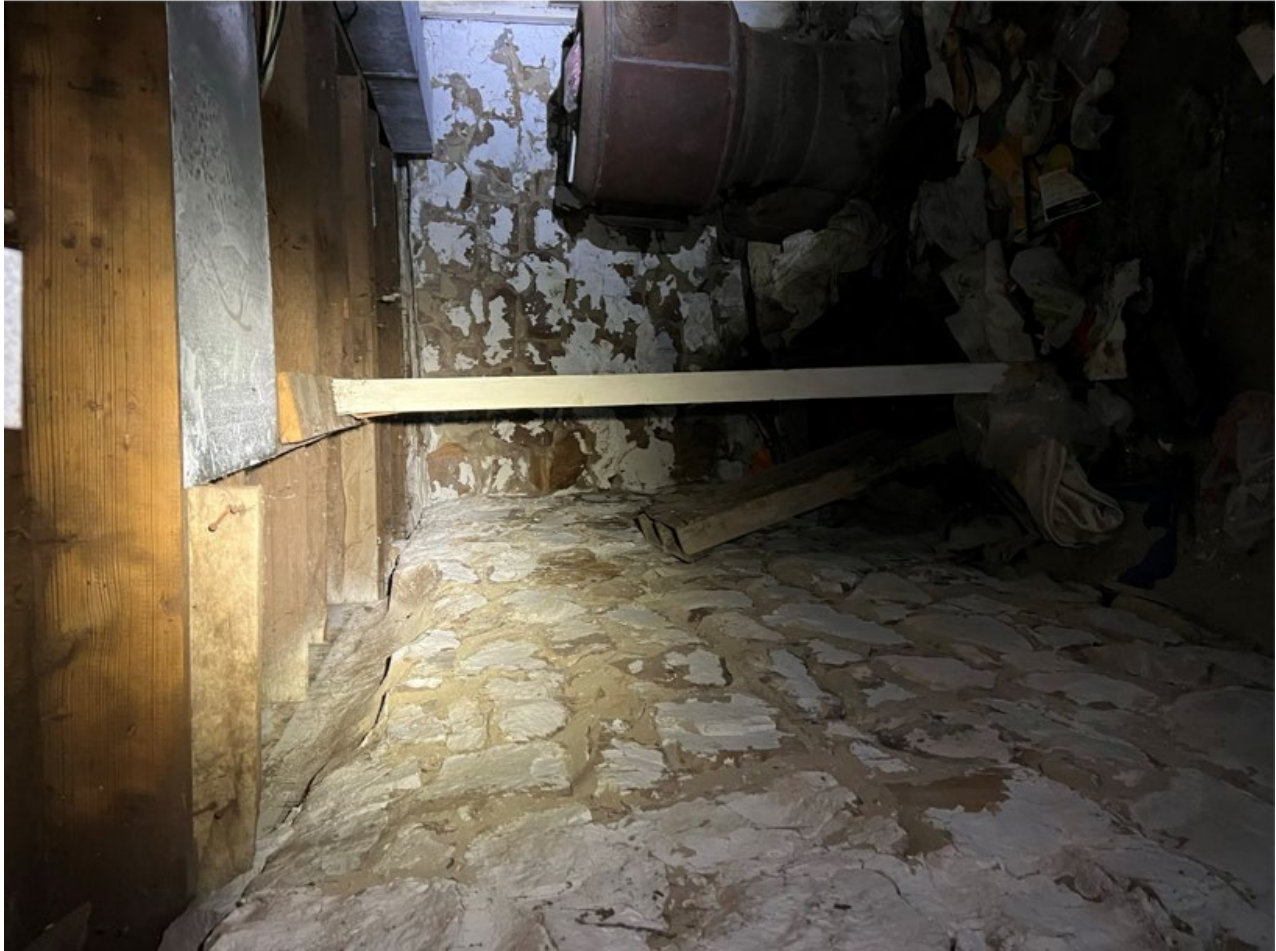
1025 S. Dakota Avenue
Foundation wall cracking in west foundation wall
